Re: Draft Restoration Plan for South Hill Bluff Restoration

Community Forestry Consultants, Inc. (CFC) has been retained by Mr. Randall Bracher to evaluate and determine the amount of damage caused to the family's property because of an unauthorized road bulldozed through the property on April 11-12, 2017. This work is being conducted as part of the damages and recovery suit Mr. Bracher filed against Swedberg Contracting. Mr. Bracher has asked that we work as quickly as possible to complete our work so restoration can be undertaken when weather and soil conditions are present to ensure a successful restoration and plantings that thrive not merely survive.

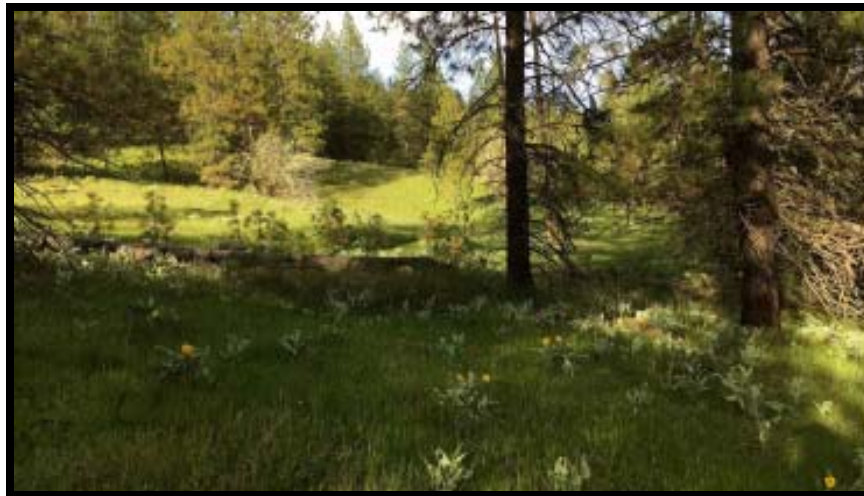
It is well documented and known that cheatgrass, dalmation toadflax, thistles, mustards, hairy vetch, filaree, tansy, and knapweed often invade sites following disturbances such as fire, logging or excavation. There is no specific detail to address this threat. Further, a common forb, arrowleaf balsamroot is missing from the list included in the DBRRP. It is present on the site and illustrated in the lower left photo #4 picture of the draft DBRRP.
